# Cancun Beach Nourishment Environmental Effects

Carlos Sánchez

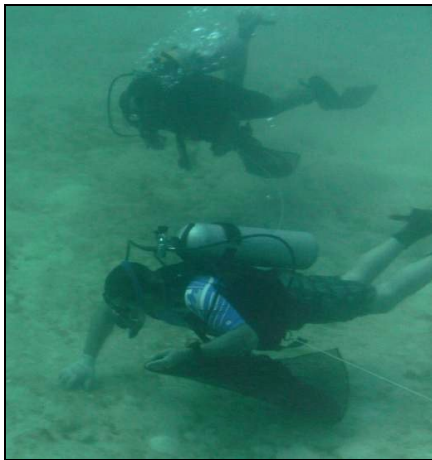
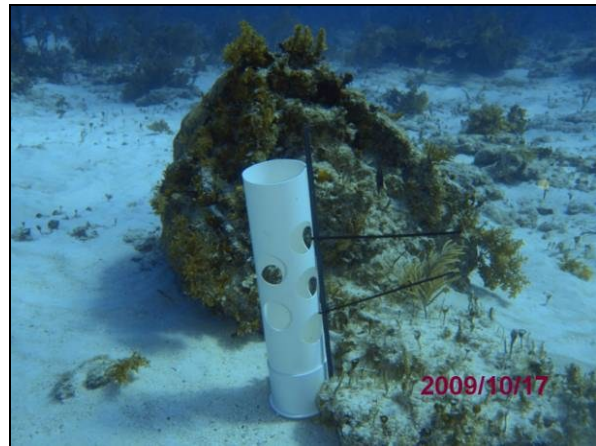
(a)

(b)

**Figure 2 (a) Sessile fauna rescue and relocation on borrow areas, (b) Coral reef monitoring.**

- Biota monitoring on borrow sand sites, by means of test channels
- Fine sediment dispersion cloud control during the sand placement on the beach
- Sessile fauna rescue and relocation on borrow sand sites

- Coral reef colonies tracking using the suggested technique on the “Manual para el monitoreo de arrecifes de coral en el Caribe y Atlántico Occidental”. This activity was effected in order to avoid the settlement of sediment transport on the coral reef colonies during and after the nourishment process.

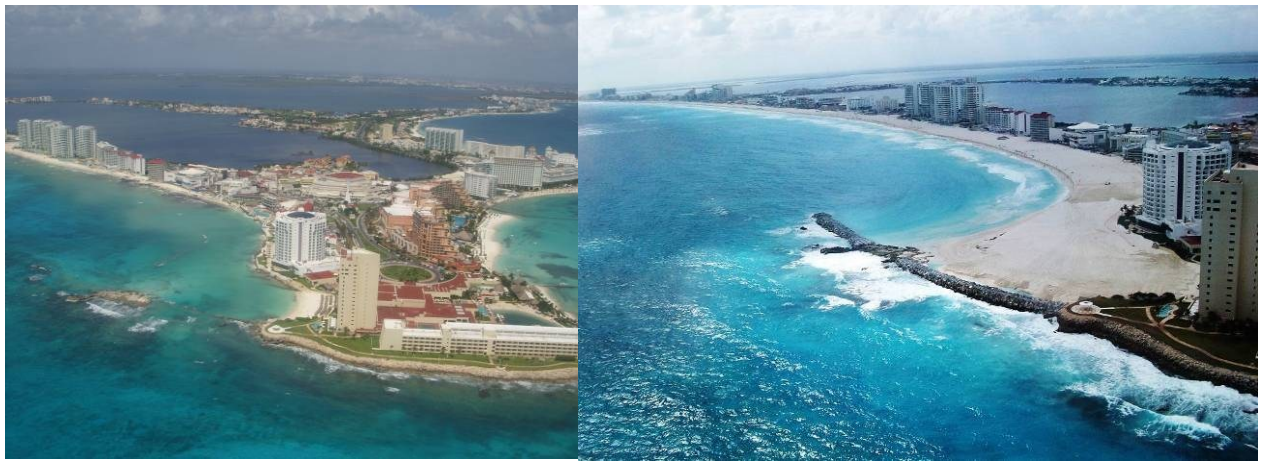
**Figure 3 Cancun Beach before and after the nourishment Project (Punta Cancun zone)**
